## Lockheed L1011-500 Tristar, CS-TMP

AAIB Bulletin No: 10/2004	Ref: EW/C2003/08/04	Category: 1.1
Aircraft Type and Registration:	Lockheed L1011-500 Tristar, CS-TMP	
No & Type of Engines:	3 Rolls-Royce RB 211-524B turbofan engines	
Year of Manufacture:	1983	
Date & Time (UTC):	19 August 2003 at 1106 hrs	
Location:	Runway 23 at Stansted Airport, Essex	
Type of Flight:	Public Transport (Positioning)	
Persons on Board:	Crew - 13	Passengers - None
Injuries:	Crew - None	Passengers - N/A
Nature of Damage:	Scoring and deformation to underside of aft fuselage, damage to No 2 engine translating cowl and hot stream duct	
Commander's Licence:	Airline Transport Pilot's Licence and Type Rating Instructor	
Commander's Age:	54 years	
Commander's Flying Experience:	11,300 hours (of which 1,200 were on type)	
	Last 90 days - 60 hours	
	Last 28 days - 28 hours	
Information Source:	AAIB Field Investigation

### Synopsis

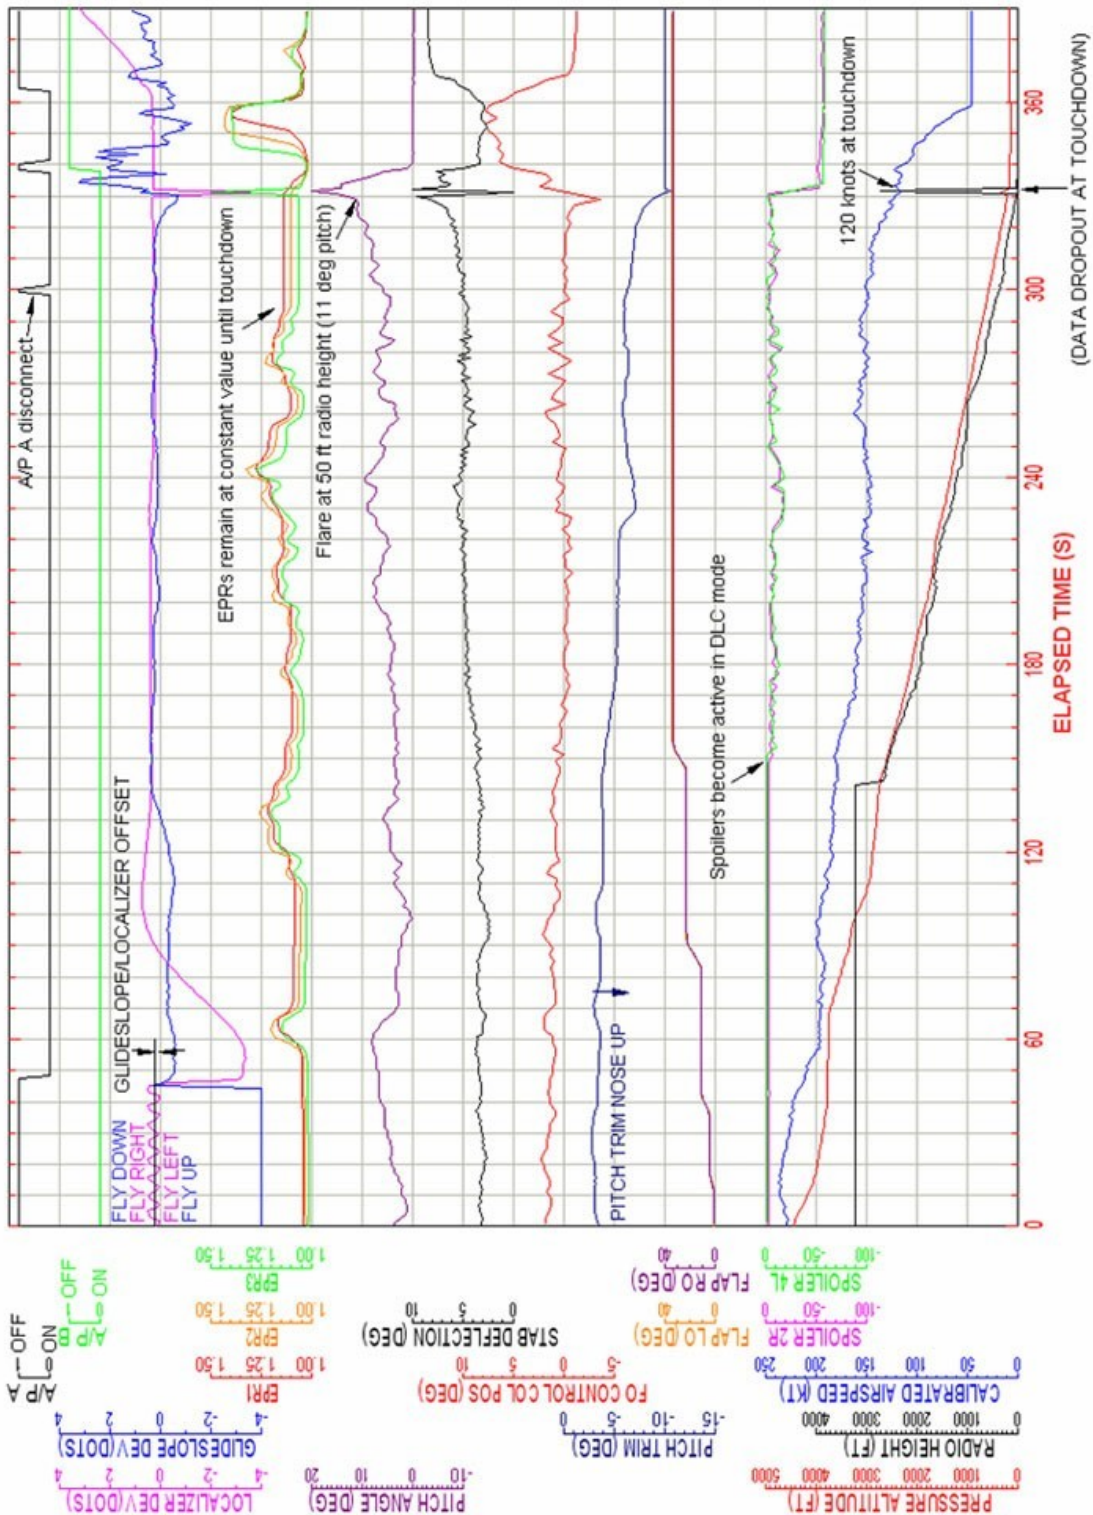
Figure 1

A time history of the relevant parameters during the landing at Stansted is shown in Figure 1. From this figure, it can be seen that A/P 'B' was already engaged when A/P 'A' was selected during the descent, at about 3,750 feet amsl, just under 5 minutes before touch down. No other distinct A/P mode discrete parameters, such as ATS or Approach/Land Mode, were available on the FDR. At A/P 'A' engagement, the localiser and glideslope deviation signals become active shortly followed by changes in the engine pressure ratios (EPRs), which had remained fairly constant at values between 1.02 and 1.05, for the previous 100 seconds. These changes in the EPRs were consistent with the ATS being active.

Salient FDR Parameters  
 (Accident to CS-TMP on 19 August 2003 at Stansted Airport)

At about 30 seconds prior to touchdown, 350 feet agl, A/P 'A' disconnected and then re-engaged. From this point, the three EPRs remained fixed at values between 1.06 and 1.14 and remained at these values until touchdown. (Five seconds prior to this point, the EPRs were already at these values, following a period where the aircraft was on or above the glideslope.) Thereafter, the aircraft pitch increased, the airspeed reduced and there was an increasing divergence below the glideslope.

At 50 feet agl, four seconds before touchdown, the pitch attitude was 11° nose-up and the airspeed was 128 kt. At touchdown, the aircraft pitch attitude was in excess of 15° nose up and the recorded airspeed was 120 kt.
