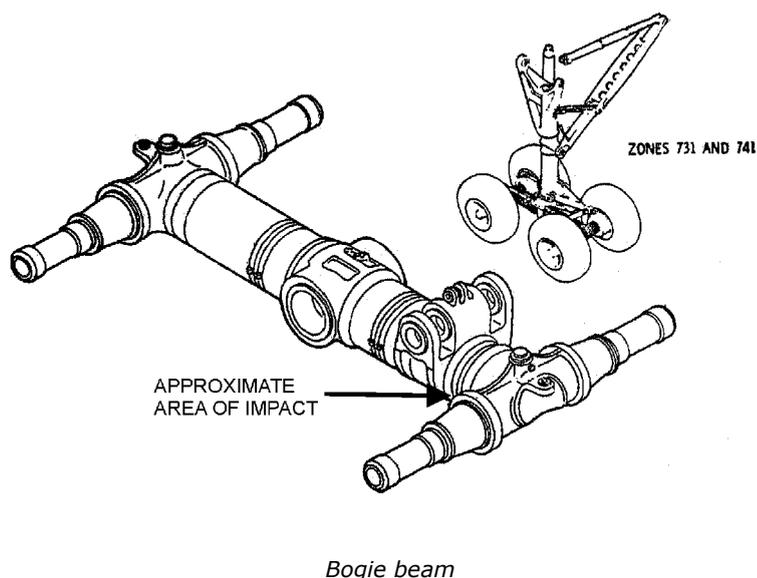
It was found that the right MLG had sustained serious damage during the rejected take-off. The brake link connection lug on its right front brake unit (see left picture) and a number of electronic and hydraulic lines of the brake- and anti-skid system of the right MLG were found broken. No other evidence of cracking was observed at that time. The four tires of the left MLG had deflated of which two tires showed large scouring spots. Three tires (two aft and one left front) of the right MLG had deflated partially. Several small parts of the right MLG were found on the runway. Subsequent to being towed from the runway, a very large crack was observed in the front part of the right MLG bogie beam (see right picture).

- Fracture of the right main landing gear bogie beam occurred due to stress corrosion cracking, which emanated from an area of mechanical damage on the right (outboard) side of the part, approximately seven inches aft of the centreline of the forward axle lug hole.
- Evidence of bubbling in the paint along the inner surface and softening of the base material along the outer surface in the area of mechanical damage, indicated that this region reached an elevated temperature.
- No material or processing defects were observed.

1. The area with mechanical damage on the bogie beam already existed before the occurrence. This damage had caused internal residual stresses in this area. The material of the bogie beam is susceptible for stress corrosion cracking. The loads on the bogie beam applied during the rejected take-off were above the stress corrosion cracking limit, causing the beam to crack.

A small aluminium part bolted to it scrapped along the beam, smearing the soft metal on it. This process caused the damage and the heating of the damaged area. The heating reduced locally the strength of the material. Under the loads on the beam during the rejected take-off it fractured.

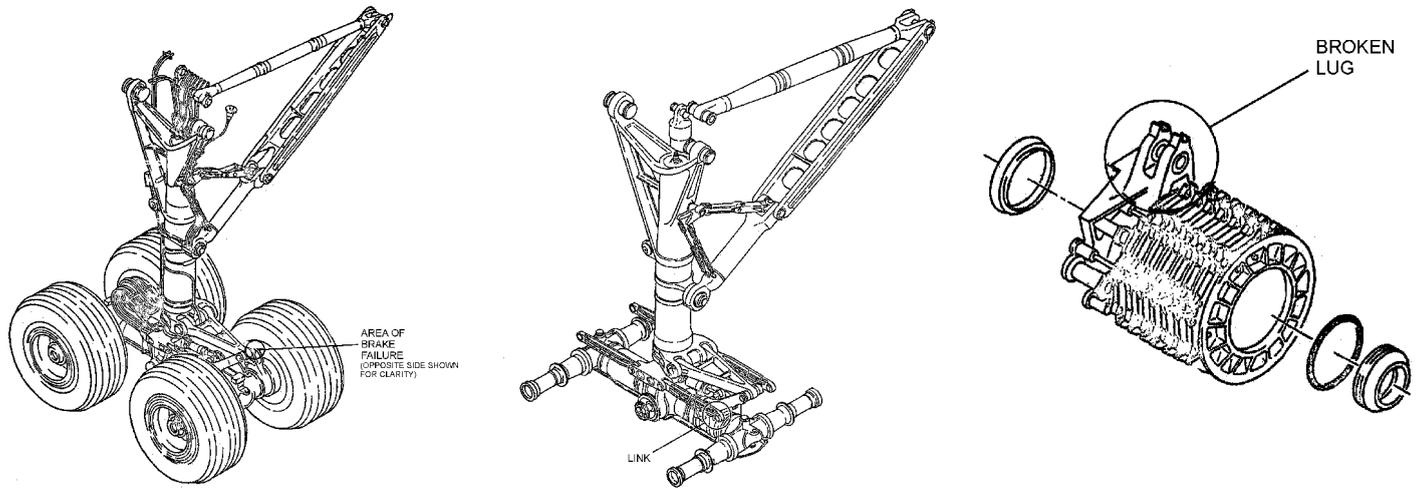
Brake link connection lug

- Investigation of fractures surfaces of the broken brake unit lug showed signs of overloading.
- At the edges some mechanical damage was present. Its cause could not be determined.

Deformations of the cracked beam caused bending at the lugs on the brake unit, resulting in fracture of them. The brake link with the free end cut the electronic and hydraulic lines of the brake and anti-skid system.

2. The lugs on the brake unit broke first. This could be a result of some pre existing deficiency in it. Too much play in the bearing, existing damage, material or processing discrepancies.
