AAIU Report No. 1999/016
AAIU File No. 19980061
Published 11/06/1999

Aircraft Type and Registration: (i) Lockheed L 1011, CS-TEB
(Civil)
(ii) Learjet LJ35, 40085 (Military)

Synopsis

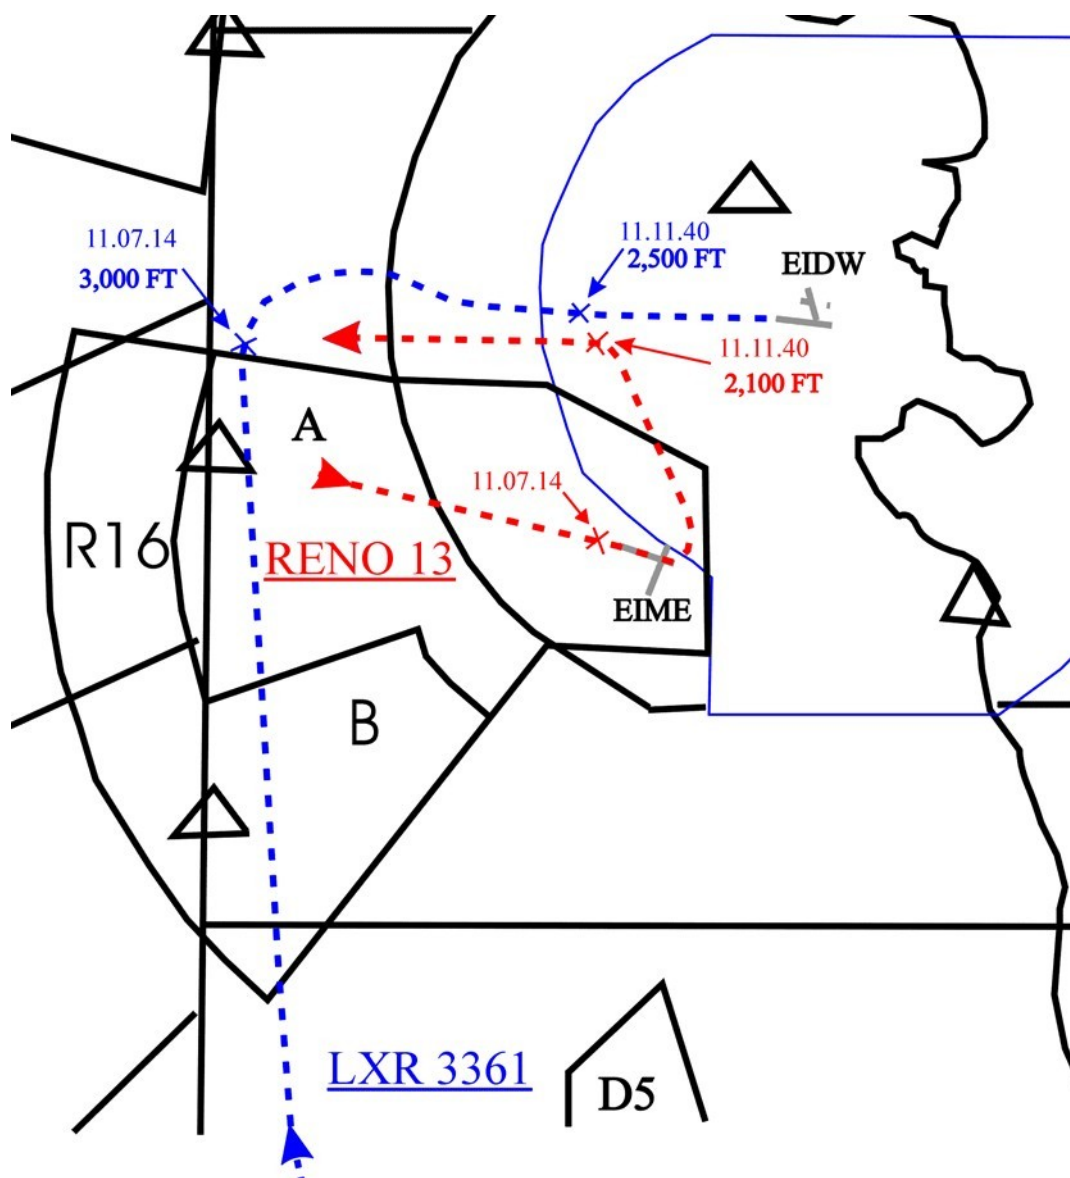
ANNEX A

The military aircraft, having passed the missed approach point, turned left as appropriate and climbed to 2,000 ft. The radar trace of the aircraft's track (see Annex A), indicates that the aircraft did not continue the turn on to a heading of 270° as required, but stopped turning on a heading of 345° with the mistaken intention of intercepting the 292° Radial to Baldonnell VOR. He continued on this heading of 345° and passed through the Dublin Control Zone boundary at about four miles from the Baldonnell VOR. The Dublin Approach controller then contacted military ATC who instructed the military aircraft to turn on to a westerly heading. By the time the military aircraft turned it was within 1.5 nm of the Luxor 3361 flight and approximately 400 ft below that aircraft.

Considering the closing speed of 360kts between the military aircraft whilst on a heading of 345° and the civilian aircraft on the ILS approach, with its vertical profile set, the risk must be considered to be in the "Risk of Collision" category.

SKETCH SHOWING FLIGHT PATHS OF
RENO 13 AND LXR 3361
