# The Dutch Safety Board

**Occurrence #:** 2004106 **Classification:** Serious incident

Date:	06-07-2004	Cockpit crew:	3
Place:	Amsterdam Airport Schiphol	Cabin crew:	12
Aircraft registration:	CS-TMR	Passengers:	314
Aircraft model:	Lockheed L-1011-385-3 Tristar 500	Injuries:	None
Type of aircraft:	Passenger aircraft		
Type of flight:	Commercial air transport, passenger	Lighting conditions:	Daylight
Phase of operation:	Take-off roll		
Damage to aircraft:	Serious

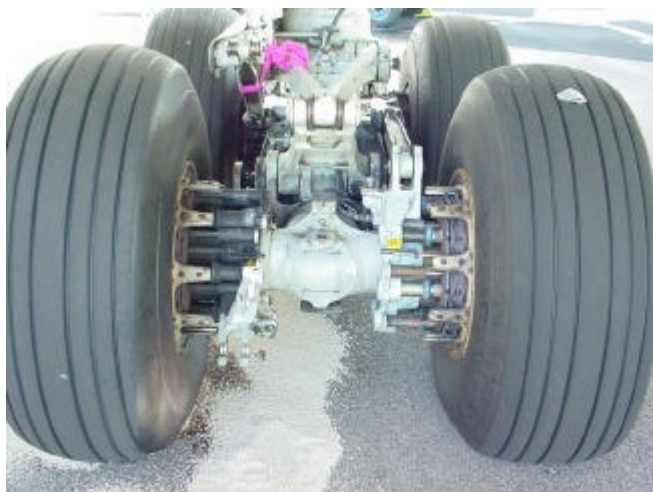
*The broken lug (bottom left) of the right MLG*

It was found that the right MLG had sustained serious damage during the rejected take-off. The brake link connection lug on its right front brake unit (see left picture) and a number of electronic and hydraulic lines of the brake- and anti-skid system of the right MLG were found broken. No other evidence of cracking was observed at that time. The four tires of the left MLG had deflated of which two tires showed large scouring spots. Three tires (two aft and one left front) of the right MLG had deflated partially. Several small parts of the right MLG were found on the runway. Subsequent to being towed from the runway, a very large crack was observed in the front part of the right MLG bogie beam (see right picture).

- Investigation of fractures surfaces of the broken brake unit lug showed signs of overloading.
- At the edges some mechanical damage was present. Its cause could not be determined.

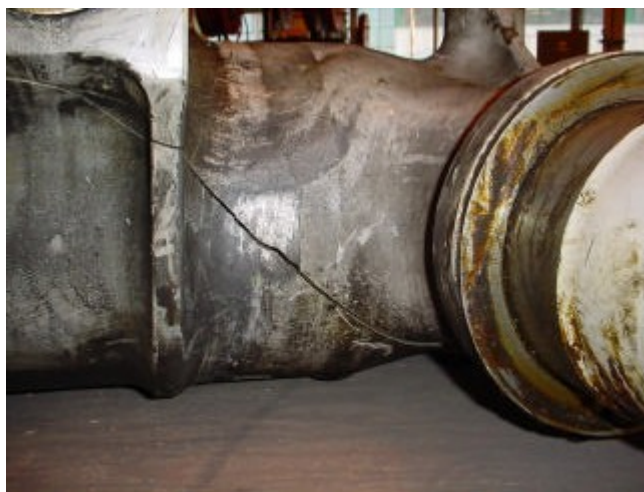
*The crack in the right MLG bogie beam*

- Fracture of the right main landing gear bogie beam occurred due to stress corrosion cracking, which emanated from an area of mechanical damage on the right (outboard) side of the part, approximately seven inches aft of the centreline of the forward axle lug hole.
- Evidence of bubbling in the paint along the inner surface and softening of the base material along the outer surface in the area of mechanical damage, indicated that this region reached an elevated temperature.
- No material or processing defects were observed.
